DAMAGE LOCALIZATION OF SLAB-ON-GIRDER BRIDGES THROUGH VIBRATION CHARACTERISICS

A Thesis
Submitted to the Graduate Faculty
of the
North Dakota State University
of Agriculture and Applied Science

Major Department:
Civil and Environmental Engineering

March 2015

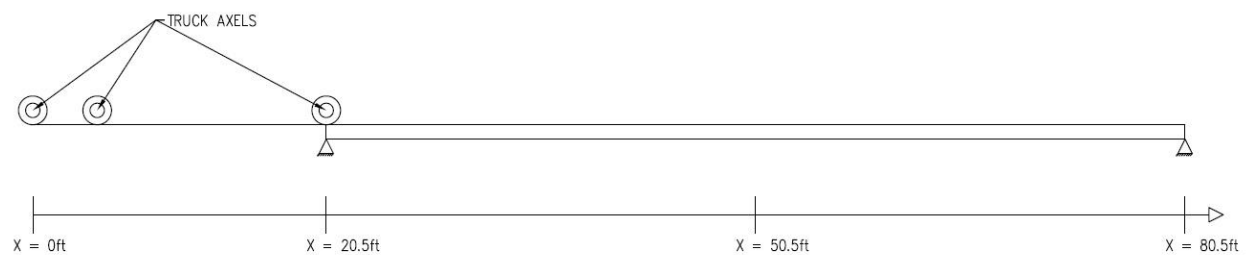
Figure 2.19. Relative bridge position

The model results obtained were directly compared to the deflection measurements collected by BDI, Inc. After several simulation trials adjusting the axial and rotational spring stiffness, a model was obtained where several locations under different load paths had a good matching with the actual deflection measurements, although, there were some parts of the model which did not match the field results. It was determined that this model could be used further for damage analysis and the initial development of a damage index. The Figure 2.20 through 2.25 show where the model was able to match the field measurement well. Figure 2.19 shows the bridge's position relative to the load position shown in Figures 2.20 through 2.25.

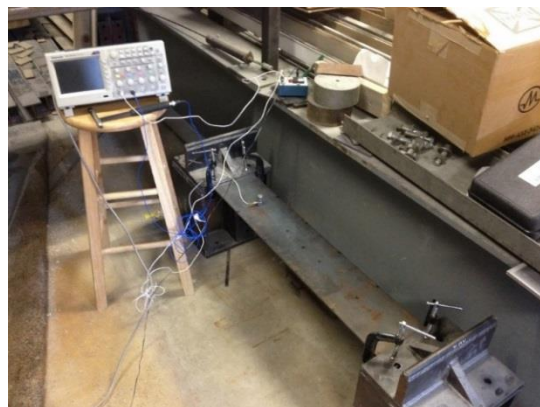
Figure 4.1. Experimental set up

The steel plate is used to provide a simple representation of a single span bridge deck similar to the bridge used in Chapter 3's numerical analysis. The steel plate is 7.0 inch by 35.0 inch in dimension with a thickness of 0.2 inch. Fixed boundary conditions were applied at the shorter edges, creating a 35.0 inch deck span. Figure 4.1 is a photo of the experimental set up. A measurement grid was applied to the steel plate, which provided 18 impact and measurement locations. Figure 4.2 shows a schematic plot of the measurement grid.
